CALIFORNIA DIVISION OF MINES AND GEOLOGY

FAULT EVALUATION REPORT FER-85

January 23, 1979

San Jacinto, Hemet area (includes segments of the Casa Loma, Claremont, and Hot Springs faults).

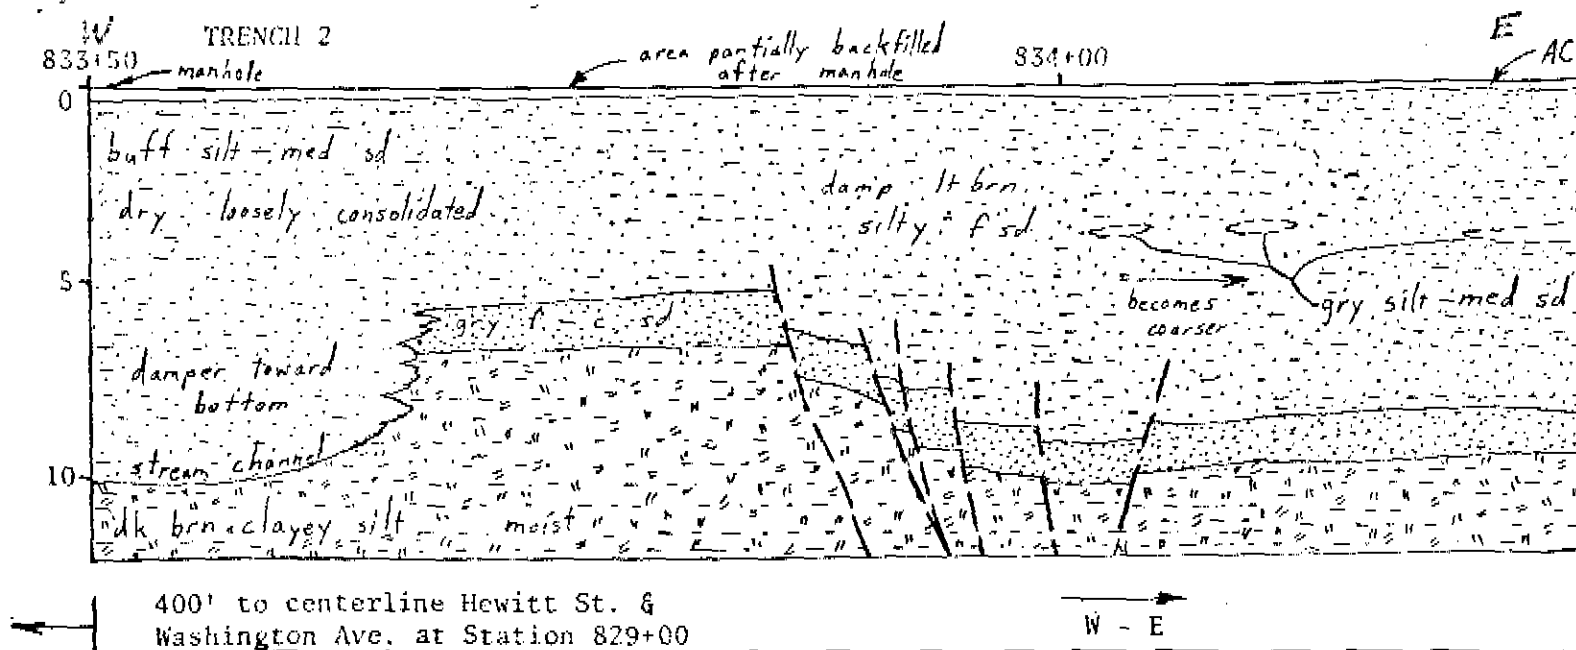
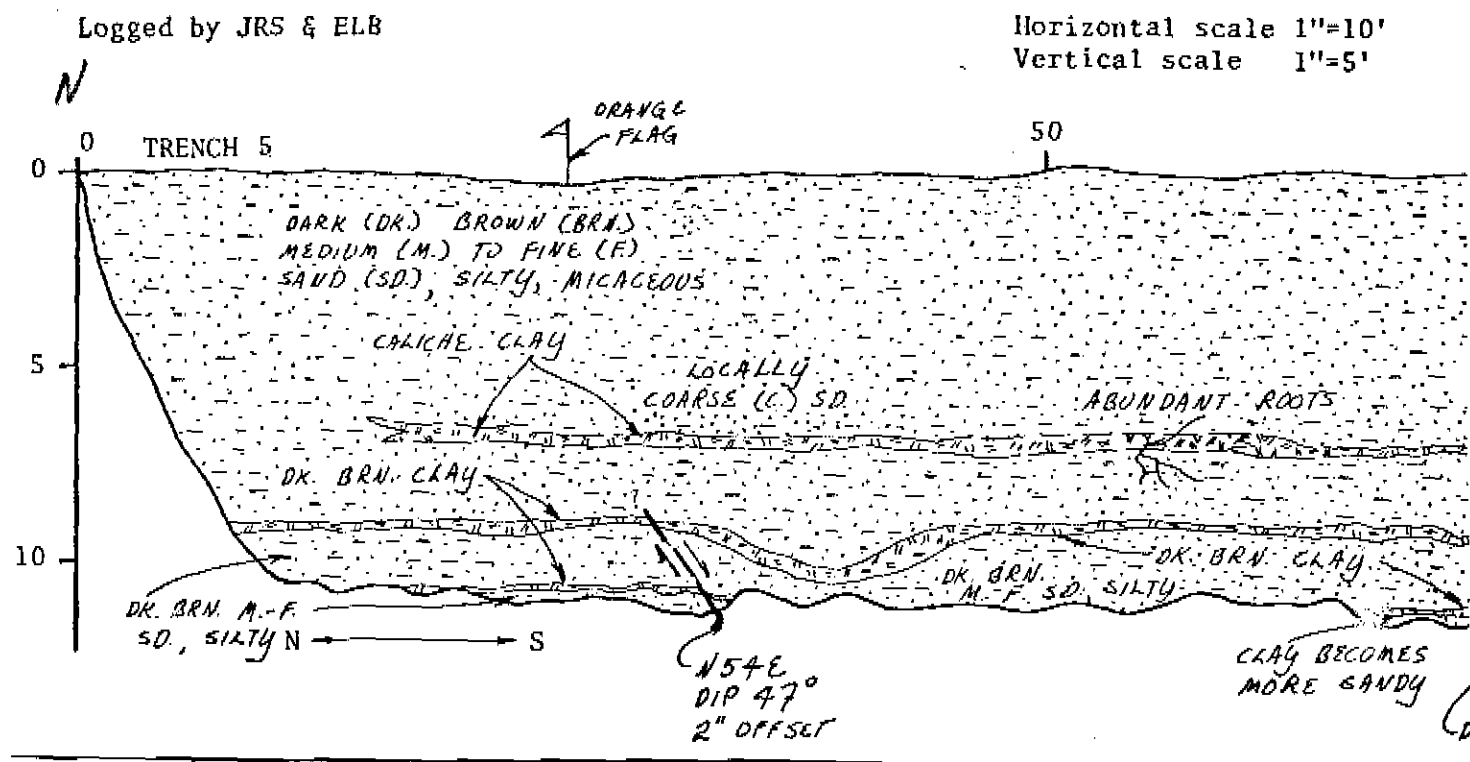
by 3.5 feet (Figure 6). This fault coincides with a tonal lineament in soil as shown in Figure 4b. The fault was not clearly identified in a trench cut in Holocene alluvium 300-400 feet to the northeast (Figure 6). However a 2-inch offset at a depth of 9 feet conceivably could be the northeast continuation of the feature. However, a bed at 7 feet of depth is not offset by the feature, indicating recent inactivity. Rasmussen (1978, p. 1 of April 12, 1978 supplement) concludes that the northeast-trending feature is due to ground failure from seismic shaking and is not a "tectonic fault." The feature was not traced to the southwest, but it cannot extend beyond the most easterly strand of the Casa Loma fault 2,000 feet away. The area to the southwest is now developed and covered by homes and streets.

Another minor fault-like feature was encountered in the sewer trench along Washington Street, 3,300 feet east of Hewite (Rasmussen, 1978). This feature trends N 32° W and offsets Holocene alluvium by 7 inches at a depth of 7.5 feet but not the young surface layers at a depth of 2 feet. A second trench cut just north of Washington Street and on-trend with the feature did not encounter the fault in the same alluvial materials. Rasmussen concludes that the feature is not through-going and probably is the result of seismic shaking. There is no surface evidence of this feature.

Figure 6. Portions of Trench 2 (sewer trench) and Trench 5 of Rasmussen (1978), who considers these northeast-trending fault-like features to be due to seismic shaking.
